3 Building Types, Materials and Styles

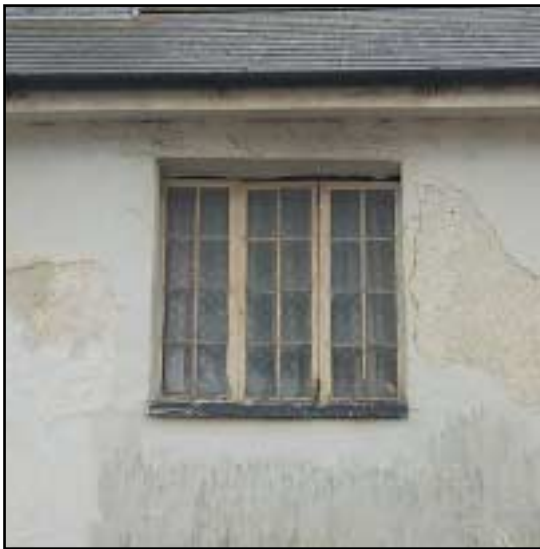
Fig 2 An early 19th century casement window

Buildings of the 16th – 18th centuries have casement windows of various ages; the earlier openings are smaller than those that have been enlarged during later modifications. Later homes, mostly of the 19th century, are deeper and taller but still built on the street frontage, albeit behind a pavement on the main road. They tend to have vertical sliding sashes that reflect their age. A significant proportion of properties have had windows replaced in styles that fail to complement their historic character, some in modern materials like PVCu.

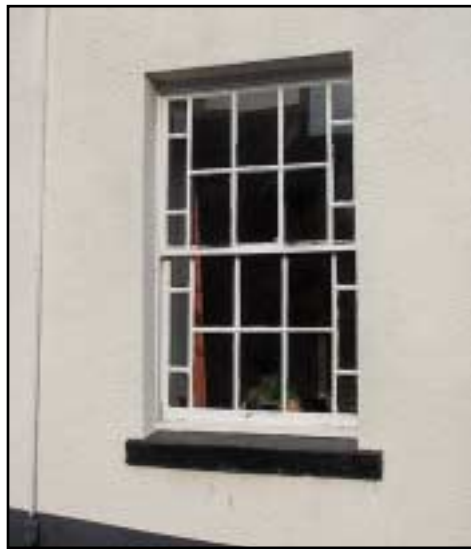
Fig 3 Decorative sash window at Court House

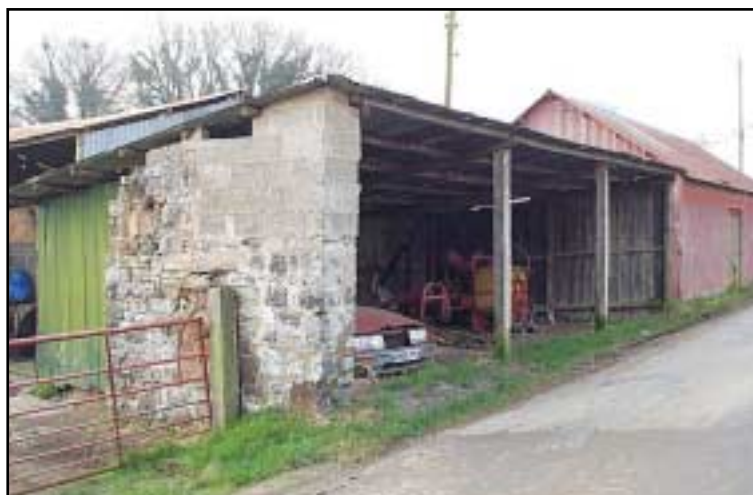
Fig 4 Corrugated iron is a traditional material

Corrugated iron is common, especially on agricultural and ancillary buildings, but also notably on the large gable of Stonelands.

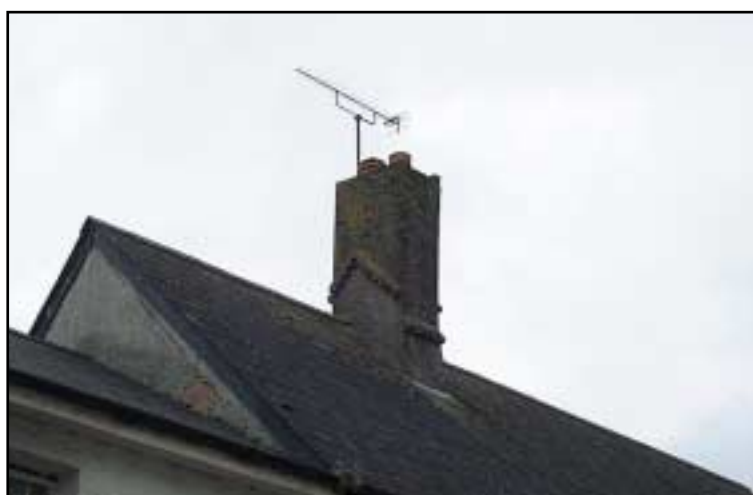
Fig 5 Chimney with brick drip course showing the height of the former thatched roof at The Old Post Office

Chimneys contribute a great deal to the character of the village. Most have brick stacks, with the notable and outstanding exception of Pilgrim Cottage that has its original granite shaft. An interesting and unusual feature of Crockernwell is the number of stacks that have drips constructed in brick. This is a distinctive local character feature that also indicates the level of formerly thatched roofs.
