4 Key Buildings

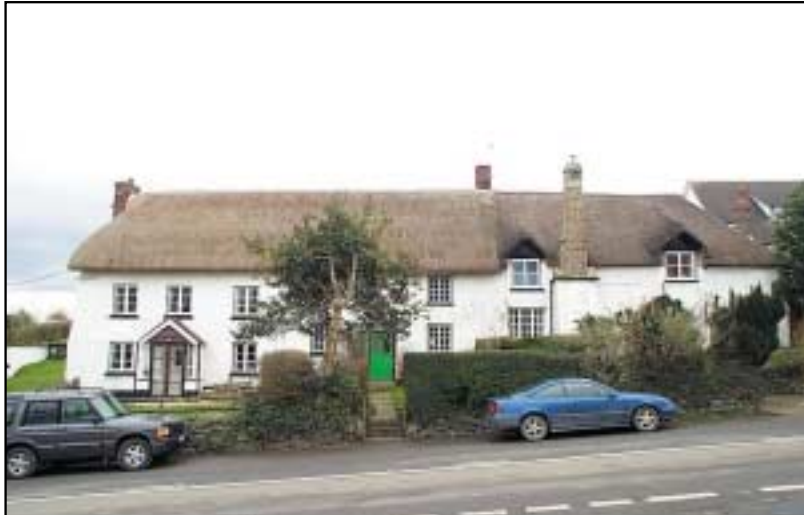
Fig 6 Lilac, Holly and Primrose Cottages

Lilac, Holly and Pilgrim Cottages: Grade II*

Originally a farmhouse built in the 16th century to the usual three room cross passage plan. Partly re-modelled in the 17th century and extended in the 18th or 19th centuries. Converted to cottages and substantially altered in the 20th century. An eye-catching range at the western end of the village.

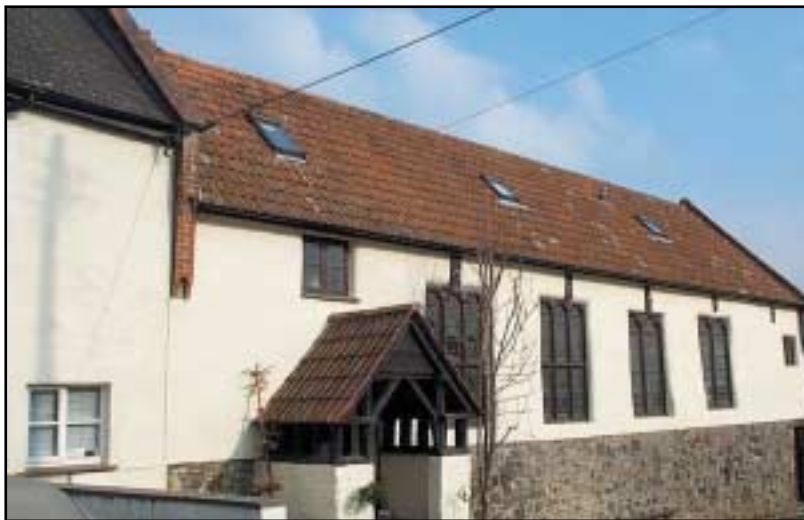
Fig 7 Holy Trinity Chapel

Holy Trinity Chapel: Grade II

This is an important and unusual building at the heart of the Conservation Area. Quite anonymous from the main road but the ecclesiastical windows are a feature of the back lane.

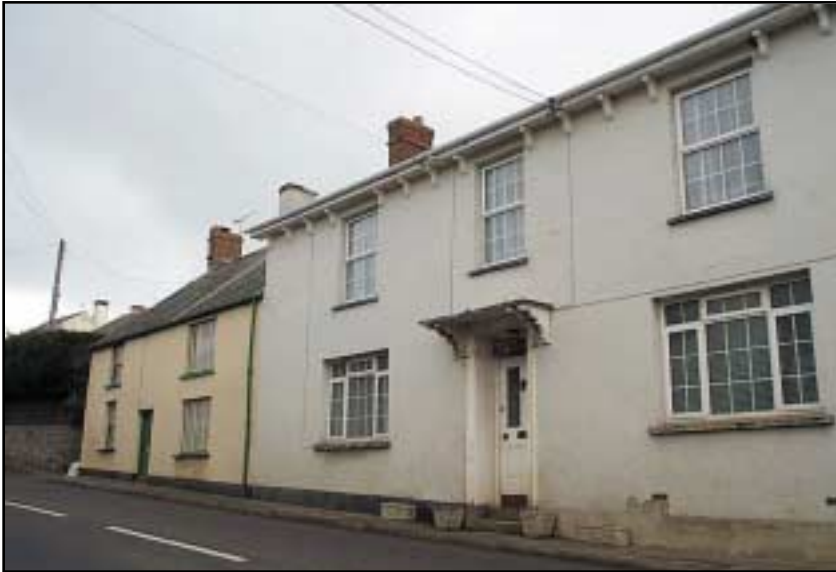
Fig 8 The former Golden Lion Inn

Golden Lion House: Unlisted

This large 19th century property, with the lower (and earlier) range to the west and its extensive outbuildings, was The Golden Lion inn. It appears to have been purpose-built when the Exeter to Okehampton road was improved – possibly before the grander Royal Hotel? The completeness of this group is rare and is an essential element in the special historic character of Crockernwell and it is located within one of the toft plots.

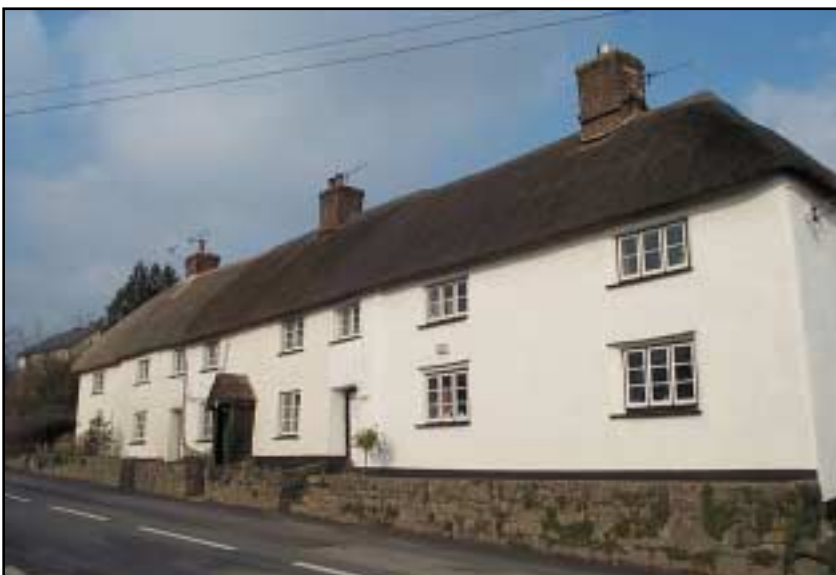
Fig 9 Fordton Cottages

Fordton Cottages: Grade II

Although they have been altered this remains a row full of character in a prominent location on the eastern edge of the settlement.

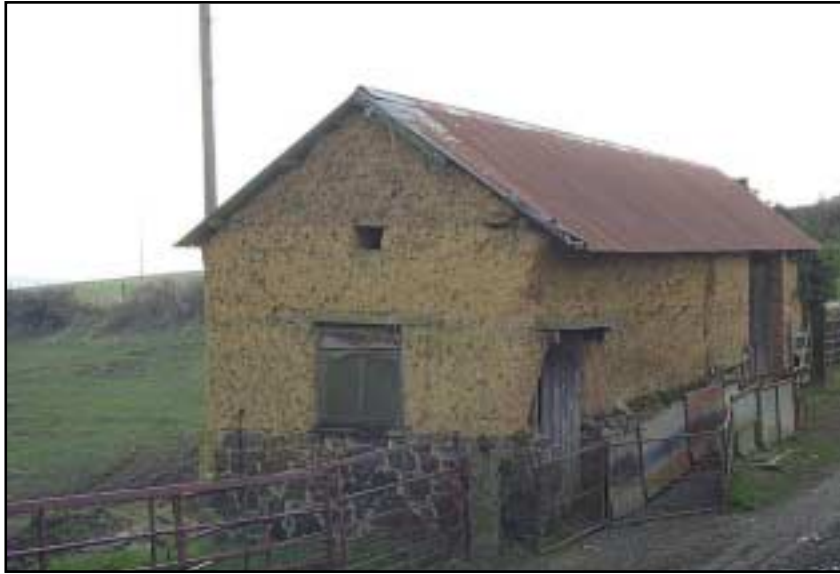
Fig 10 Cob barn

Cob barn at Budbrook: Unlisted

A narrow and strongly linear 19th century stone and cob barn with later adaptations, prominent in views of Crockernwell from the east. One of a pair of barns of about the same age – the other immediately to the west now collapsed. Another stone barn north of this has partially collapsed and further loss of this historic group would be a significant loss to the character of the Conservation Area.

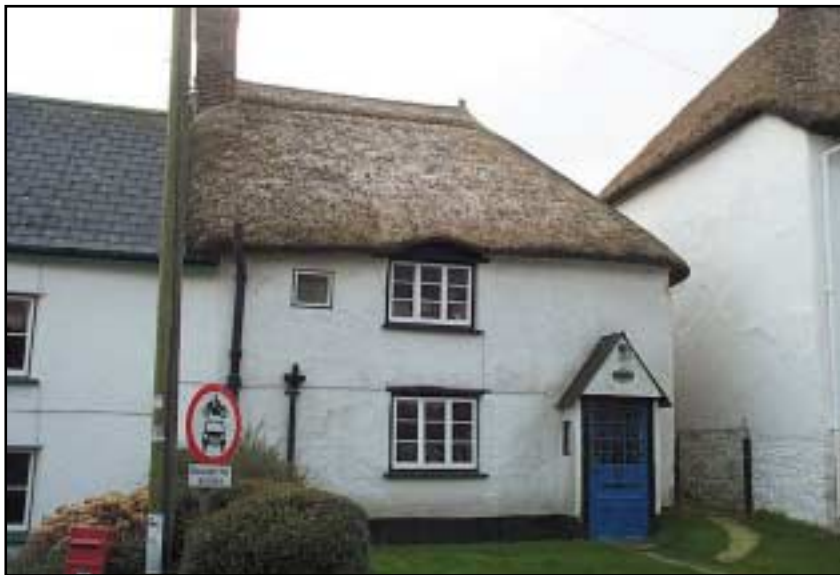
Fig 11 Oak Beam Cottage

Oak Beam Cottage: Grade II

Although the fenestration has been re-ordered this cottage encapsulates the historic character of cottages in the old centre. The survival of thatch here shows how much impact the introduction of slate and tile has had.

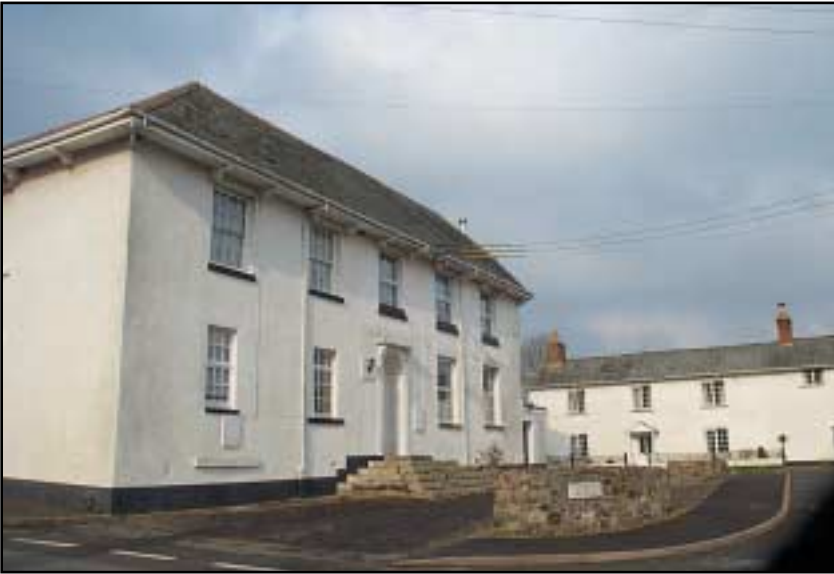
Fig 12 The former Royal Hotel

Court House (formerly The Royal Hotel): Unlisted

Built end on to the main road, this substantial 19th century coaching house and its associated buildings retain an impressive presence.

The surviving historic sashes give an impression of the status the owners sought to convey. Alterations to the building and its setting have rather diminished its historic character.

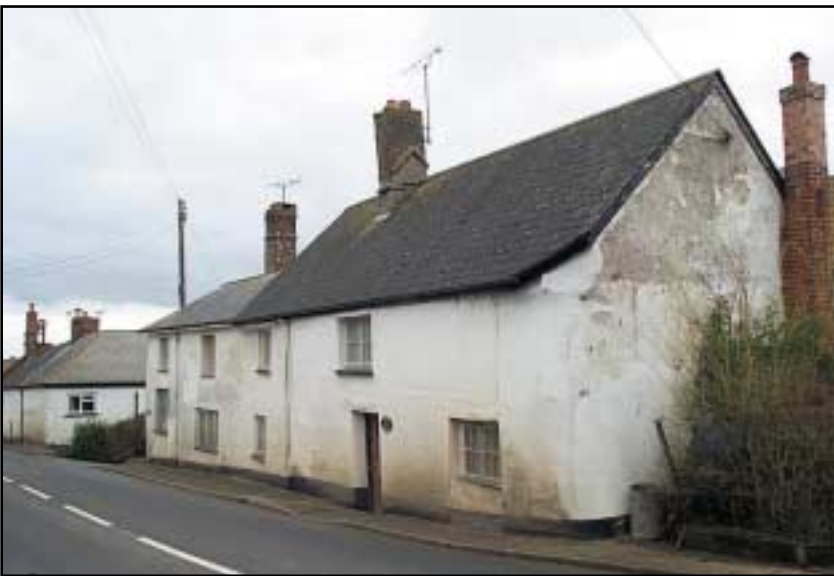
Fig 13 The Cottage and Old Post Office

The Old Post Office and The Cottage: Unlisted

The prominent location of the formerly thatched historic dwelling, once the Post Office, makes it a focal point for those passing through. The Cottage has an interestingly curved south elevation which is an attractive character feature on the back lane.

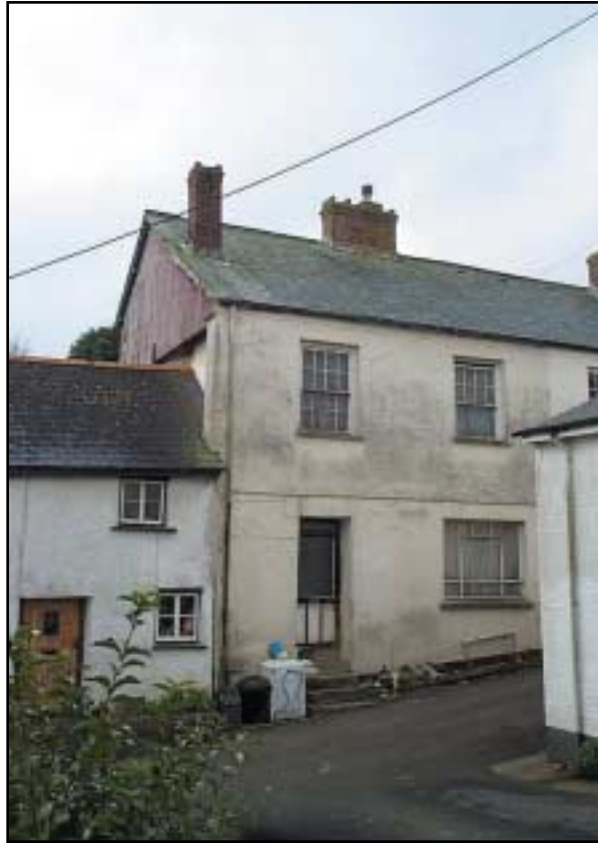
Fig 14 Stonelands

Stonelands: Unlisted

The sudden change in depth of plan and ceiling heights, compared to the old cottages either side, gives this 19th century building a colossal presence. An eye-catching and characteristic building because of the context into which it was inserted.
