## 5 Local Details and Street Furniture

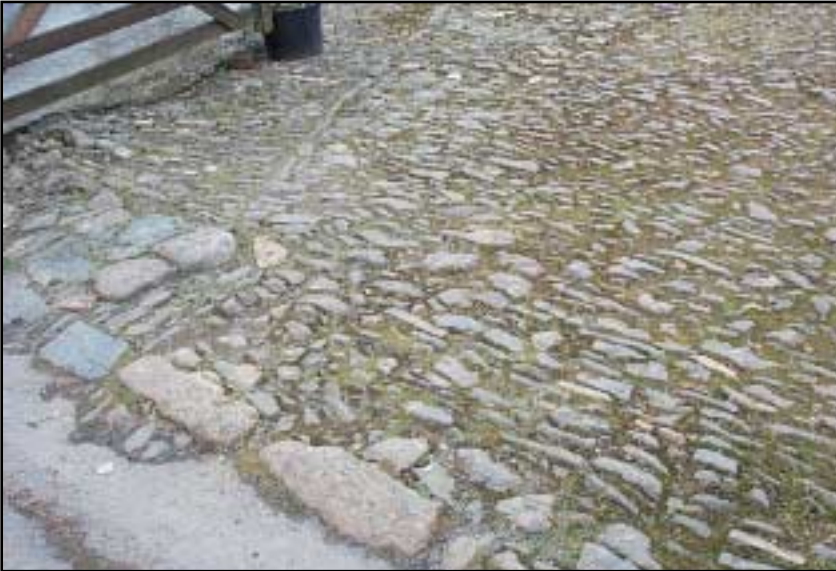
Fig 19 The cobbled yard at Gill House

There is a notable absence of street furniture such as signs, street lighting and the like. It is hard, however, to find a pleasing view in North Brentor that is not in some way diminished by the intrusive presence of overhead wires and cables. The general lack of pavements reflects the rural character of the Conservation Area, though a number of properties are fronted by stark concrete – notably at Chapel View. The most attractive survival of historic paving is in the courtyard behind Gill House. A small patch of cobbles survives outside Heatherlands.

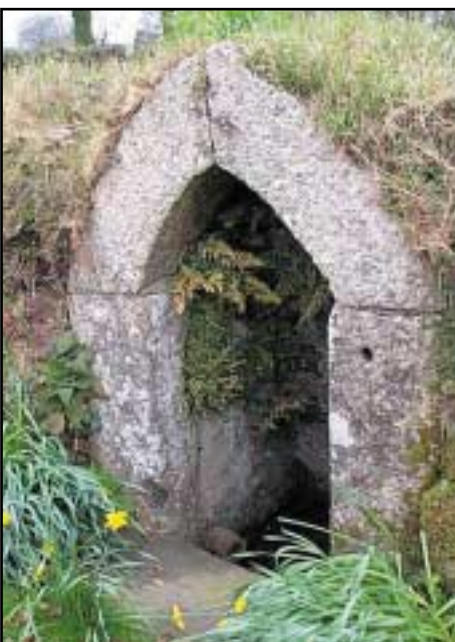
Fig 20 The well head

The influence of water is ever-present, especially in the central green spine - from the moss-draped stones on the walls, to the running water in the gulleys and the village pond opposite the church. The well head east of the war memorial is one of the most distinctive character features of the village and is complemented by the pyramid capstone dated 1883 on the conduit pipe a little way to the south east.

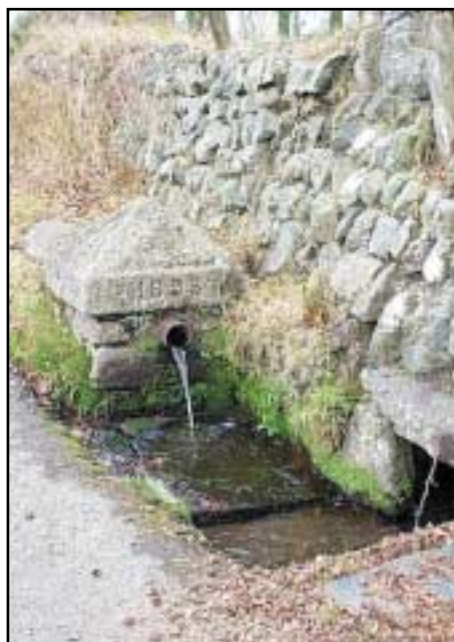
Fig 21 Conduit with datestone

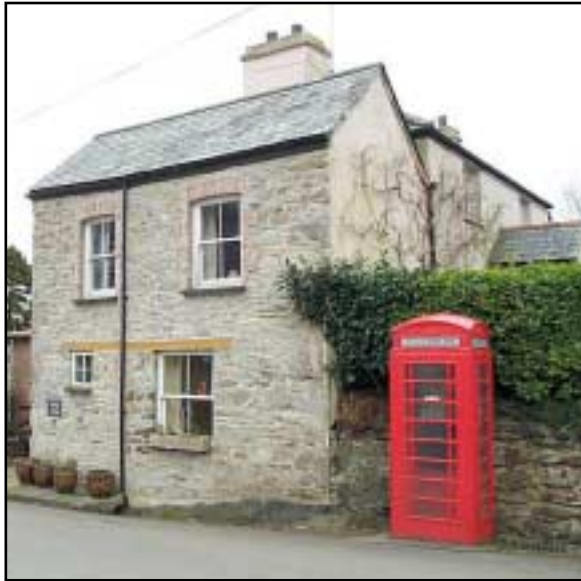
Fig 22 The K6 telephone kiosk

On the other side of the road there is the red K6 telephone kiosk and the post box marks the location of the former Post Office. The key focal point is, however, the war memorial. Located in the middle of the T-junction it is unavoidable and has a strong, direct relationship with Christ Church.

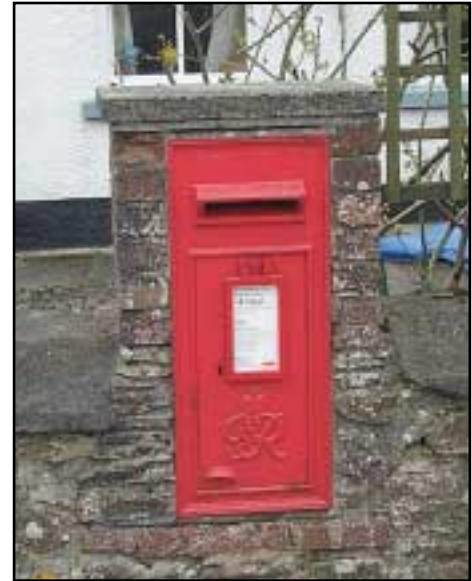
Fig 23 The post box

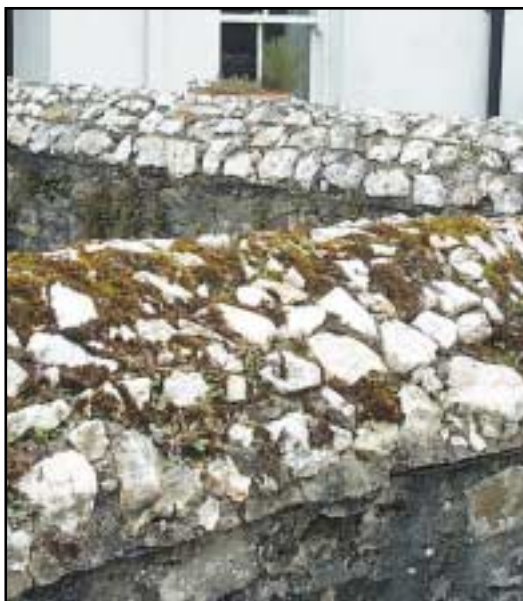
Fig 24 Rubble stone wall with white quartz capping

Historic enclosure is provided mainly by rubble stone walls. Garden walls are generally laid in lime mortar and some have a decorative capping of white veinous quartz – likely to have been a by-product of the mining activity in the area. A number of granite gateposts survive, some are plain, others more decorative. A few good iron gates may be seen and the property immediately west of the chapel has bold iron railings. Field boundaries are more often laid dry in banks and are sometimes coursed. In recent years there have been a number of timber boarded and panelled fences erected that invariably detract from the street scene.

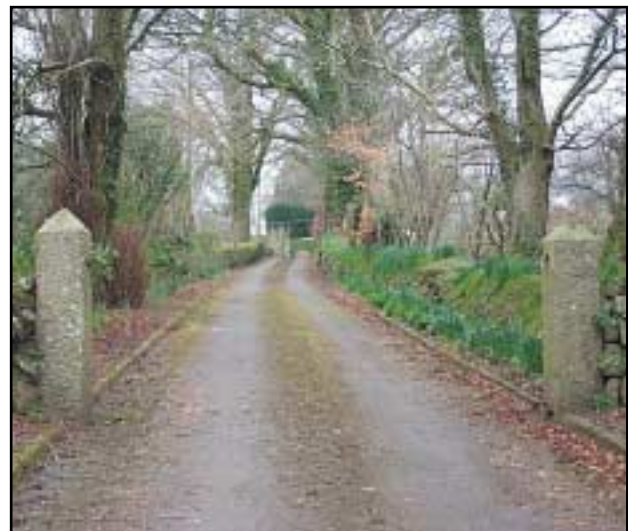
Fig 25 Granite gateposts at the entrance to Bonnaford
