## 5 Local Details and Street Furniture

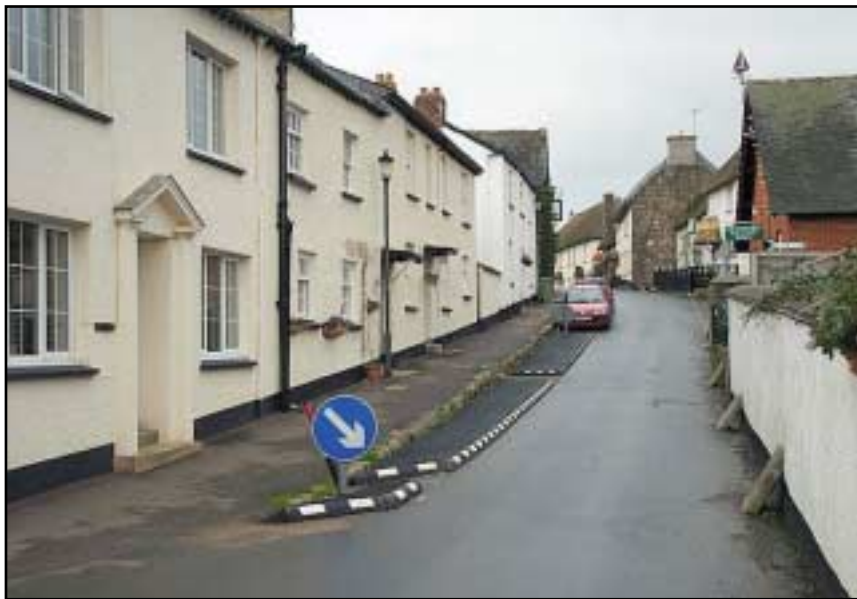
*Fig 23: Traffic calming on the main street*

The themed pseudo-historic street light is found throughout the village. By day they appear somewhat incongruous and by night the village seems rather over-illuminated. The number of traffic signs has been recently increased along with the insertion of a very utilitarian traffic-calming scheme. The tarmac islands, plastic kerbs and excessive signage detract from the raised pavements and surrounding buildings. The effect is significantly detrimental to the special character of the Conservation Area.

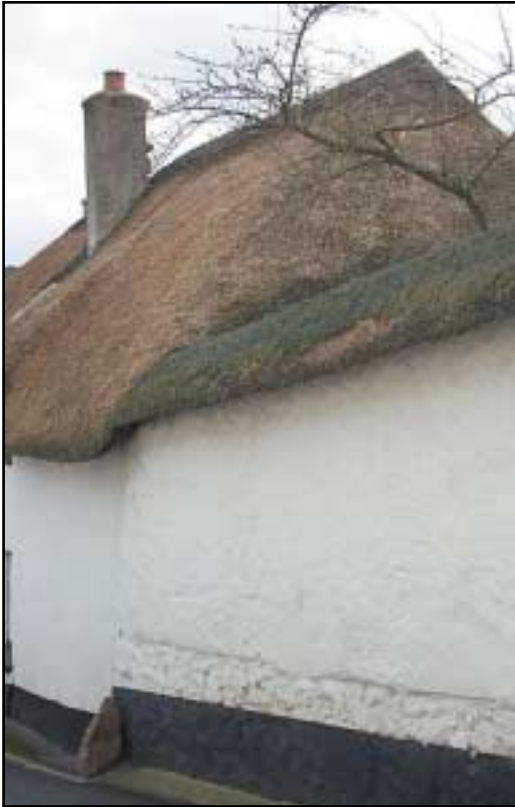
*Fig 24: The wall between Dymonds and Brimblecombes is the finest example of traditional enclosure in Dunsford*

There are two kinds of walls that abound – tall walls in rendered cob with a variety of cappings but all originally thatched, and stone walls in granite or assorted rubble stone. The cob walls are a particularly typical element of the streetscape in Dunsford and some fine examples are found enclosing gardens as well. These have lost their render in some cases but the scale of the walls and the sense of enclosure they offer to the streetscene throughout the village is distinctive. The walls that frame the top end of Briton Street Lane epitomise the character of cob boundary walls.

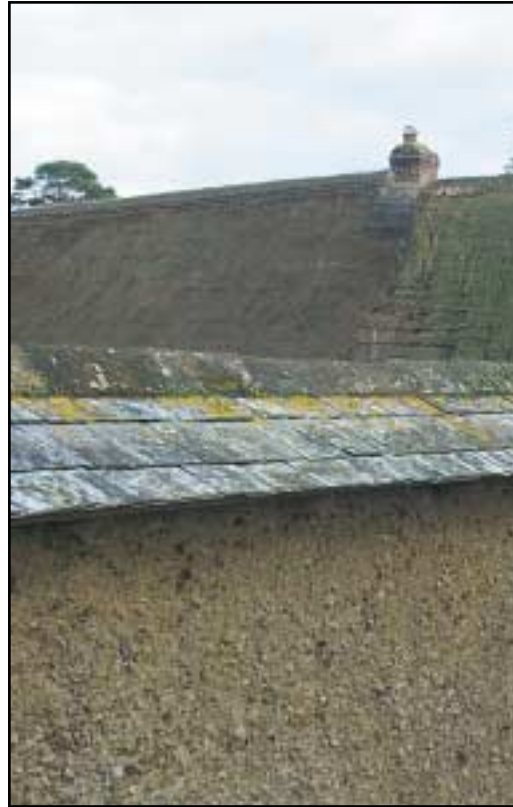
*Fig 25: A bare cob wall between East Steps and the churchyard*

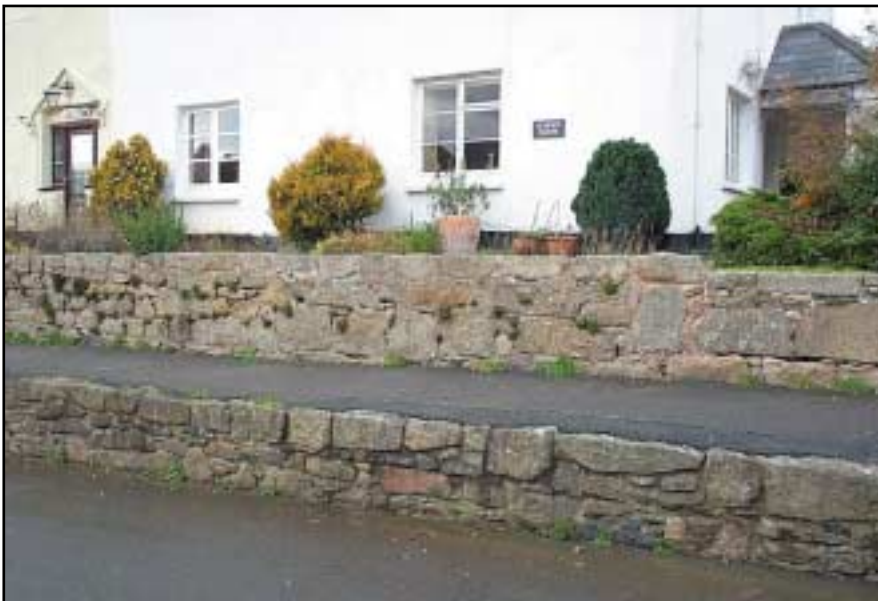
*Fig 26: Raised pavement and garden wall at Old School House*

The stone walls vary considerably, from rough rubble to dressed granite. As well as the prominent examples at the churchyard and Lewishill, there are other interesting walls like the garden wall north of Doone Cottage and the wall at Old School Cottage. The revetment walls that support the raised pavements are another theme of the village.

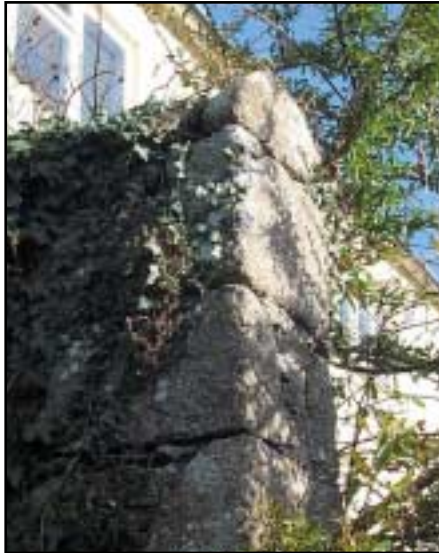
*Fig 27: Dressed granite wall at Old School Cottage*

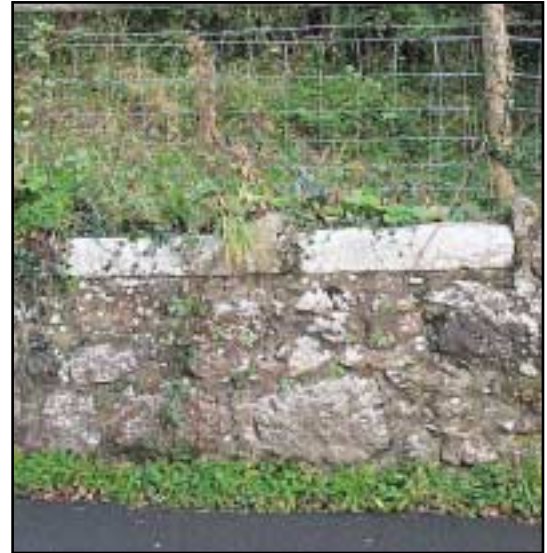
*Fig 28: Rubble wall with granite slab coping near Doone Cottage*

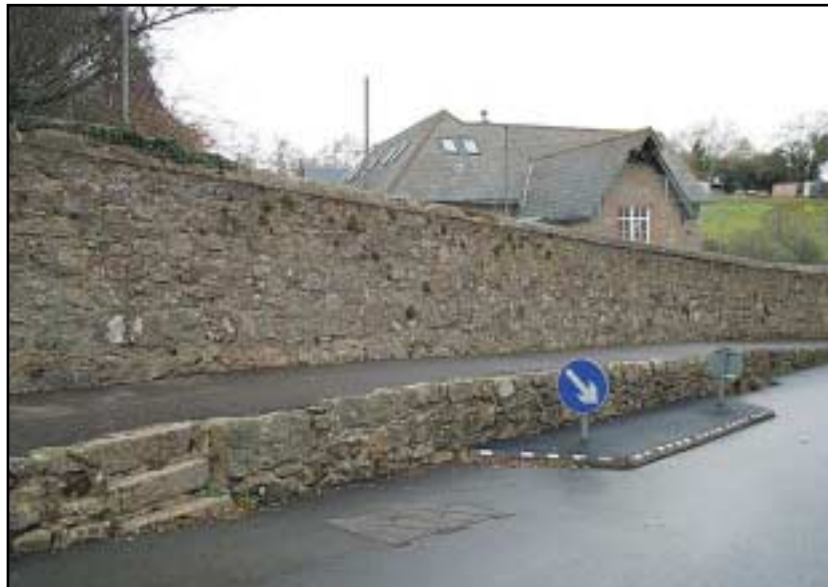
*Fig 29: Raised pavement and steps beside the school*

These are a feature of some villages and many towns in Devon and are usually an indication that the settlement enjoyed sufficient wealth and status to seek such enhancements. West of the church the pavement is almost continuous on the north side of the main street as far as the edge of the village beyond Townsend. At intervals there are granite steps linking to road level.

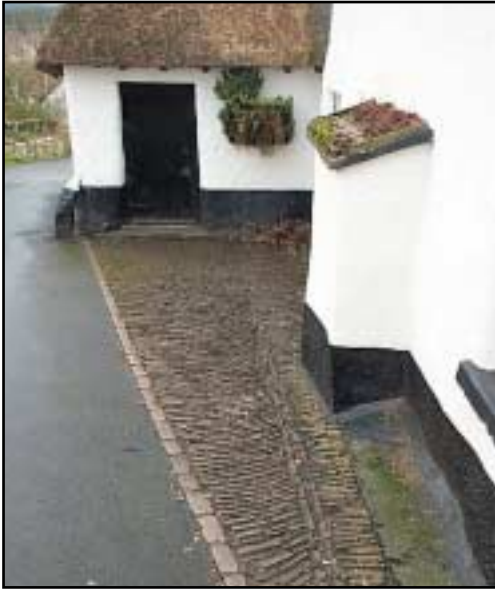
*Fig 30: The efficiently designed cobbling at Brimblecombes*

There are some outstanding examples of traditional cobbling in Dunsford. As well as the church path the areas in front of the Post Office and Brimblecombes are particularly fine. Other good examples include the patches at the bottom of the sets of church steps. Where pavements exist they are mostly edged with granite kerbs that offer a sense of quality and continuity to the streetscene.

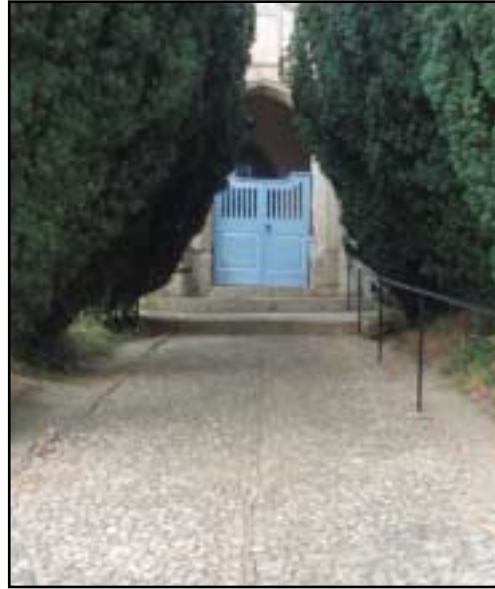
*Fig 31: The church path*

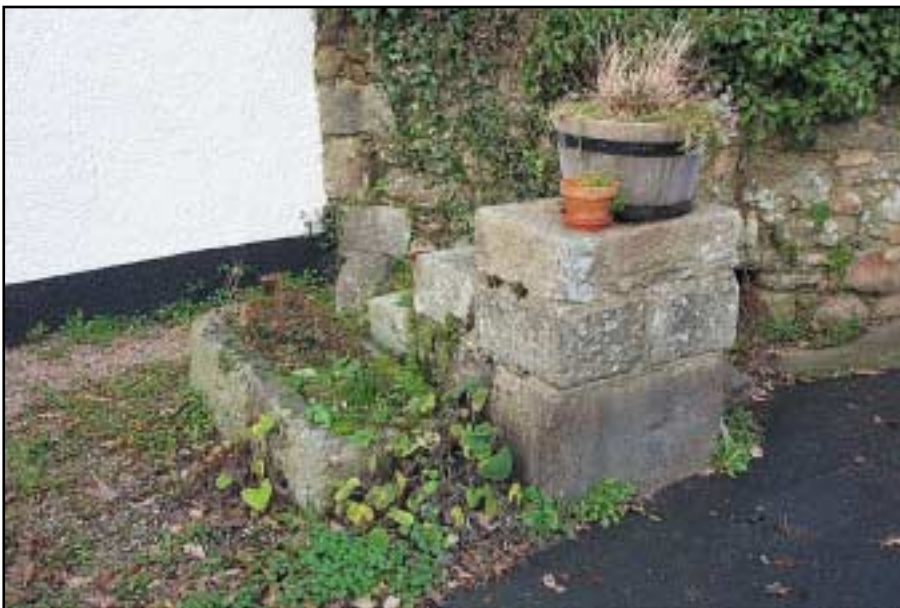
*Fig 32: Mounting block and granite trough at Foxhole*

There are two good mounting blocks in the centre of the village, outside the Old Post Office and Foxhole. These are in situ and are reminders of past times when horses were part of everyday life.

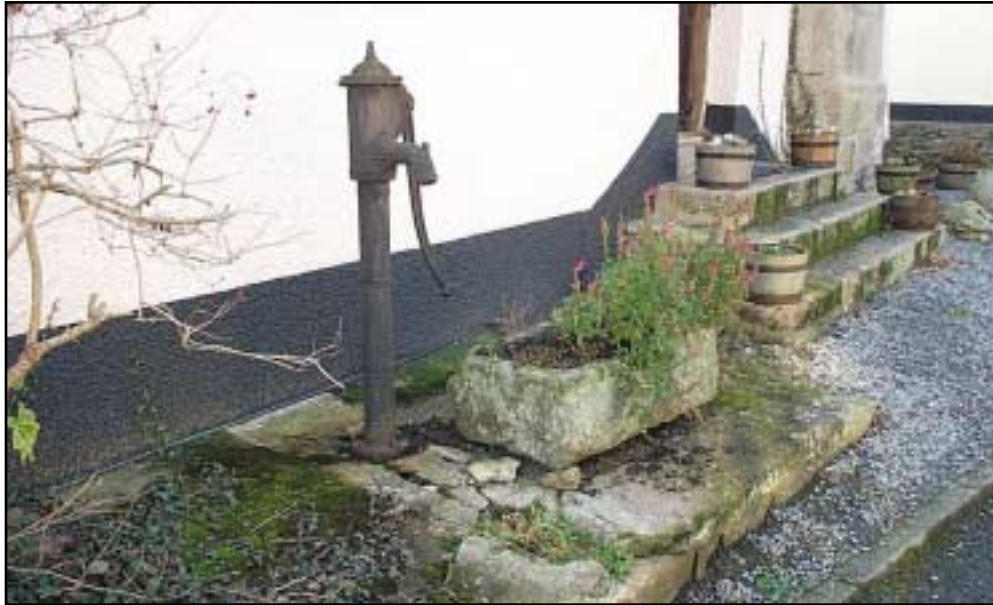
*Fig 33: Pump, trough and steps at Old Cawte Farmhouse*

A variety of granite troughs are used as planters on roadside verges. In many cases this is presumably to deter vehicles as much as to add colour and interest. A significant number of properties have old granite steps that add to the richness of the streetscene. The grandest example is at Old Cawte Farmhouse, which also has a trough and pump adding to its setting. The more modest and purely functional steps, seen on a lot of other properties, are also important - a good example is at Poppy Cottage. The converted roadside barn called Felspar has an attractive external stair but the context is rather diluted by the modern window at the top replacing the doorway.

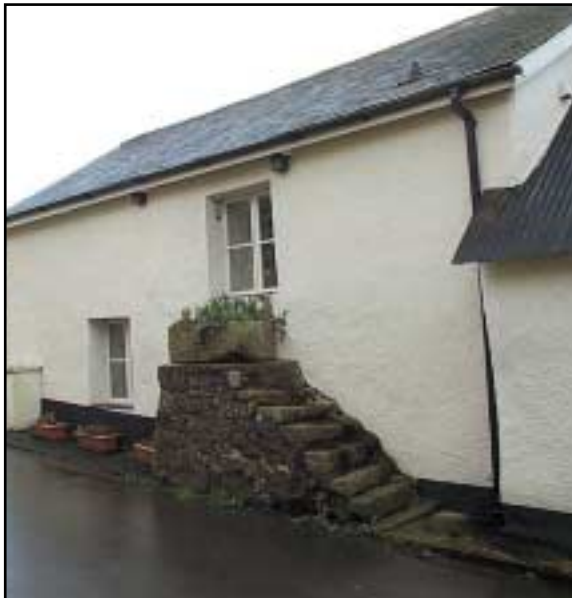
*Fig 34: Barn steps at Felspar*

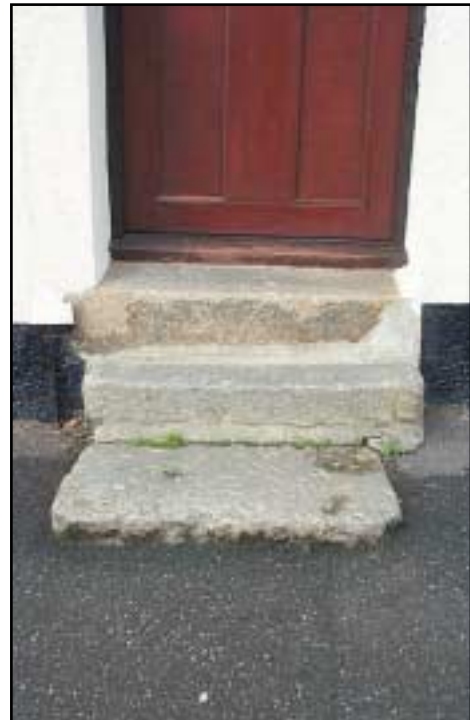
*Fig 35: Steps at Poppy Cottage*

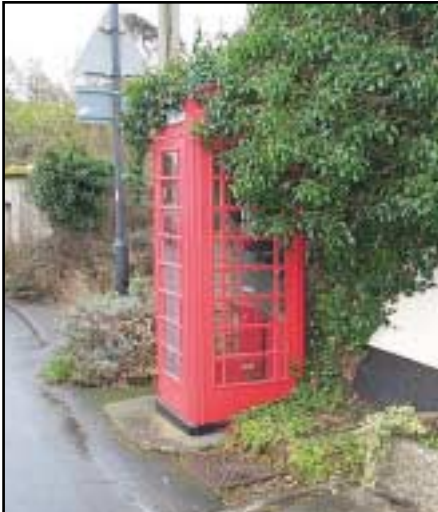
*Fig 36: The telephone box and another granite trough*

The Grade II listed red phonebox makes a traditional contribution to the village centre opposite the churchyard.

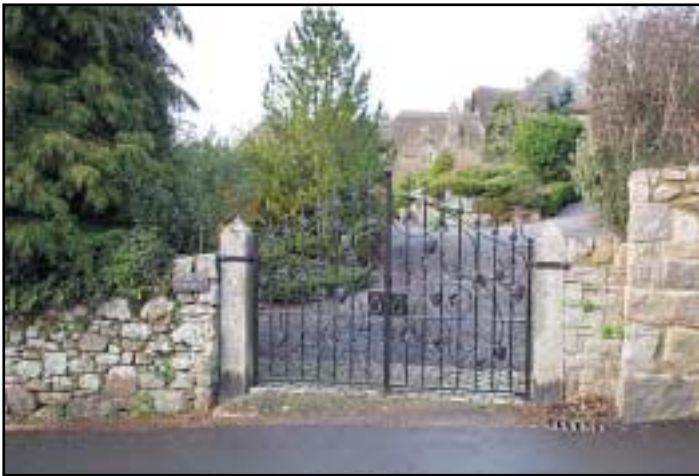
*Fig 37: The entrance to Lewishill*

As there is a strong sense of enclosure in Dunsford, created by the tight building lines and the substantial boundary walls, gaps are all the more apparent. Fortunately many are framed by granite posts that range from the ancient to the carefully sculpted. Some granite posts have also been re-used as traffic deterrents. The cart entrance in the front elevation of East Steps is an interesting feature.

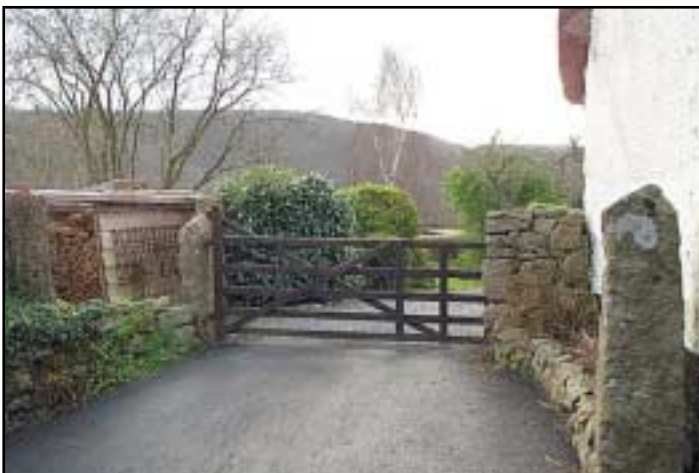
*Fig 38: Ancient gateposts re-used and in situ at Brimblecombes*
