## 5 Local Details and Street Furniture

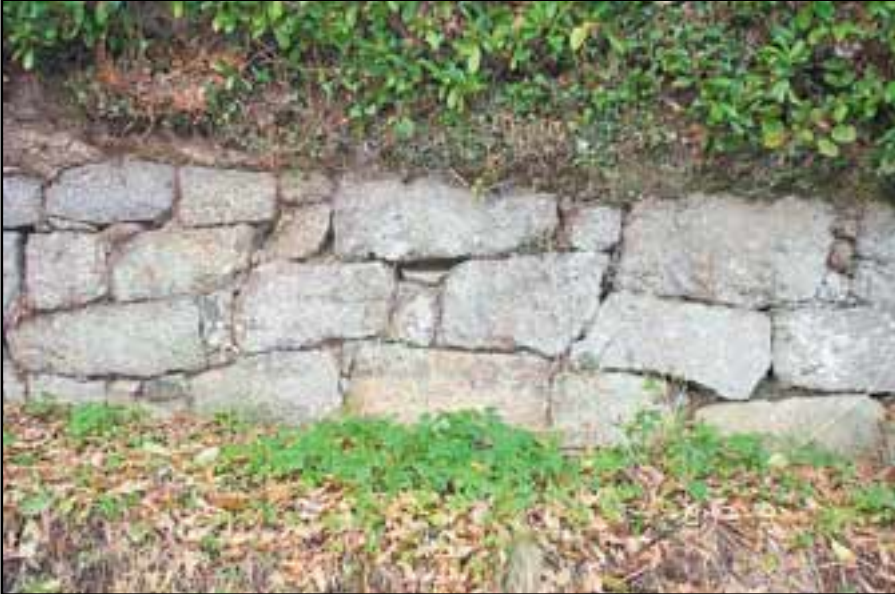
Fig 25 : Granite block wall retaining the churchyard

Roadside walls constructed in assorted styles of granite rubble are a very strong unifying feature of Throwleigh - the huge blocks in the retaining walls near the church are especially impressive (fig 25 page 23). Many walls are supplemented by hedges which include a lot of laurel as well as other plants including privet and beech.

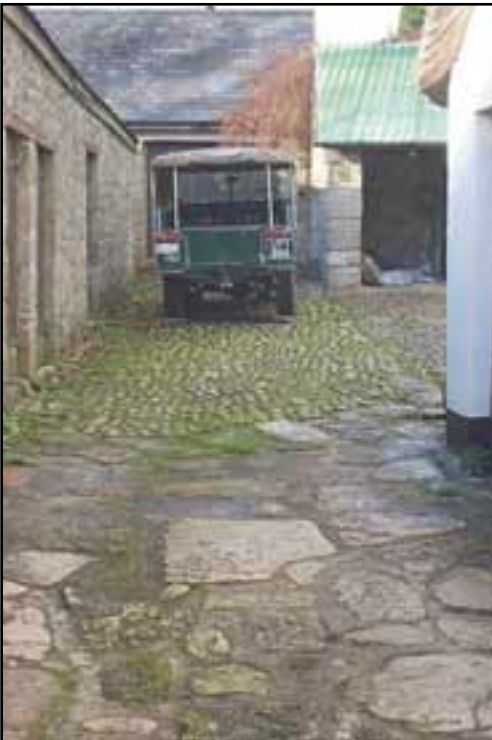
Fig 26 : Traditional surfacing at Throwleigh Barton

The courtyard at Throwleigh Barton is the only extensive survival of historic surfacing, with granite slabs at the entrance giving way to irregular setts further in (fig 26 page 23). Wayside has a little cobbling at its entrance (fig 8 page 14).

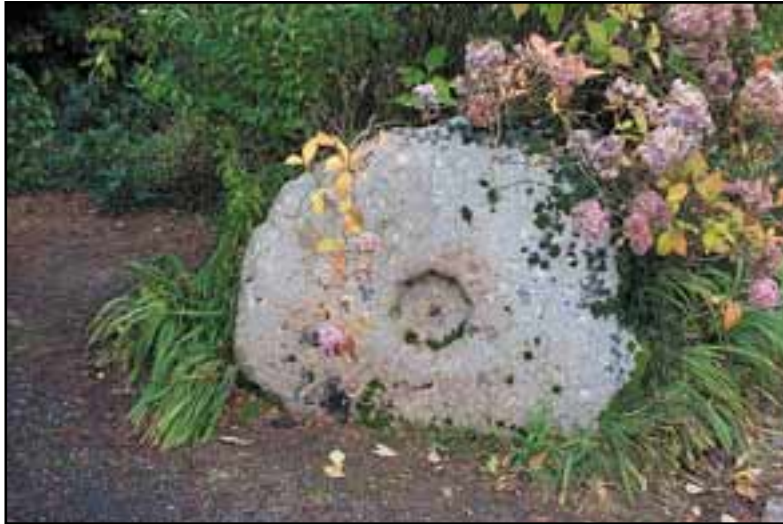
*Fig 27 : The millstone*

The millstone near the village pond is a feature; but a confusing one as there is no evidence for a mill here (fig 27 page 24).
